TECHNICAL MEMORANDUM

Subject: East Hampton Airport Noise Mitigation Program
Preliminary Results of the Noise Measurement Program;
Phase I – June 25th to July 8th 2003

Preliminary Results of the Noise Measurement Program: Phase I

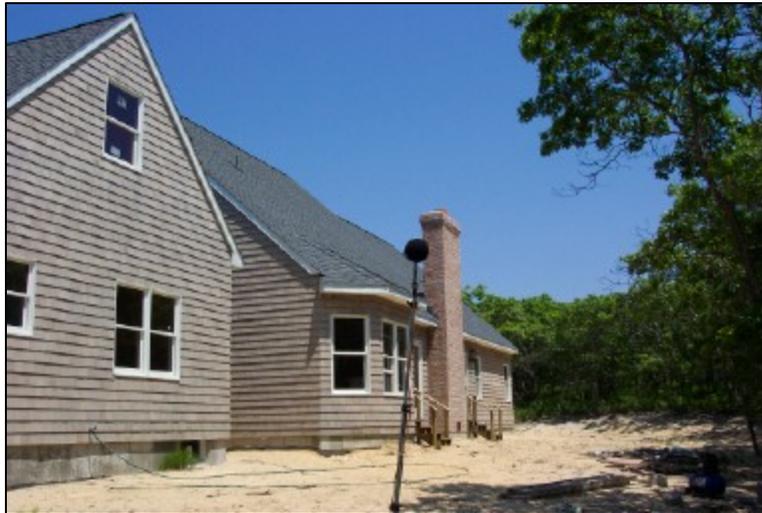
Figure 1. Microphone Location for Site 1

Site 1 was located in the backyard of a single-family home located at 11 Highview Drive in Wainscott. This site was north of the airport, approximately 3200 feet from the end of Runway 16/34 and 1000 feet west of the extended runway centerline. Figure 1 shows the location of the microphone in the backyard of this residence.

Site 1 was selected to document helicopter traffic patterns and operations. The site is located roughly 500 feet north of a power line that is used as a reference for helicopter pilots on approach to Runway 16.

In general, helicopter operations generated the highest noise levels at Site 1. The measured SEL for noise events generated by observed helicopter operations ranged from 66 to 92 dBA, while the measured L_{max} for observed helicopter noise events ranged from 60 to 83 dBA.

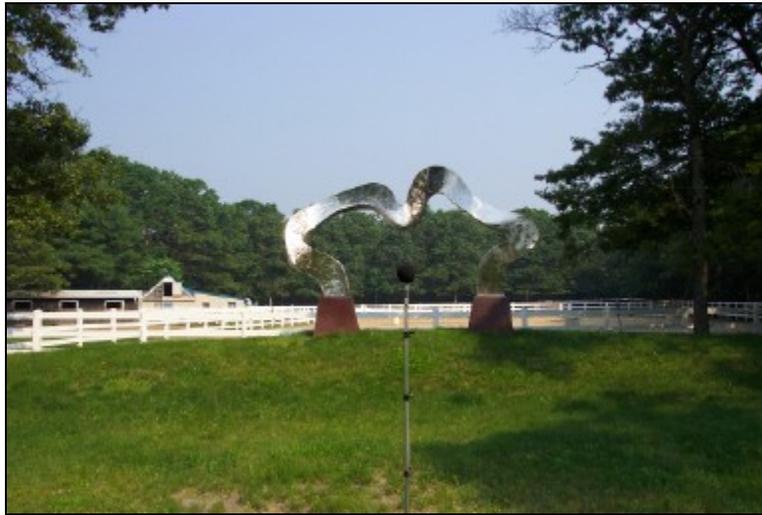
Figure 2. Microphone Location for Site 2A

Sites 2 and 2A were located in the yards of single-family homes located at 103 and 93 Merchants Path, respectively. These sites were situated west of the airport, approximately 5200 feet from the end of Runway 10/28 and 1700 feet south of the extended runway centerline. Figure 2 shows the location of the microphone in the front yard of the residence at 93 Merchants Path.

Sites 2 and 2A were selected to obtain noise levels and document aircraft operations from Runway 10/28. Attended noise measurements were conducted on June 26th from 10:45 to 12:58, on June 26th from 16:40 to 17:04, on June 27th from 09:24 to 12:32, on July 1st from 09:45 to 12:34, on July 7th from 17:15 to 18:31, and on July 8th from 09:15 to 13:00.

In general, jet aircraft operations generated the highest noise levels at Site 2. The measured SEL generated by observed jet aircraft operations ranged from 71 to 91 dBA, while the measured L_{max} for observed jet aircraft noise events ranged from 62 to 84 dBA.

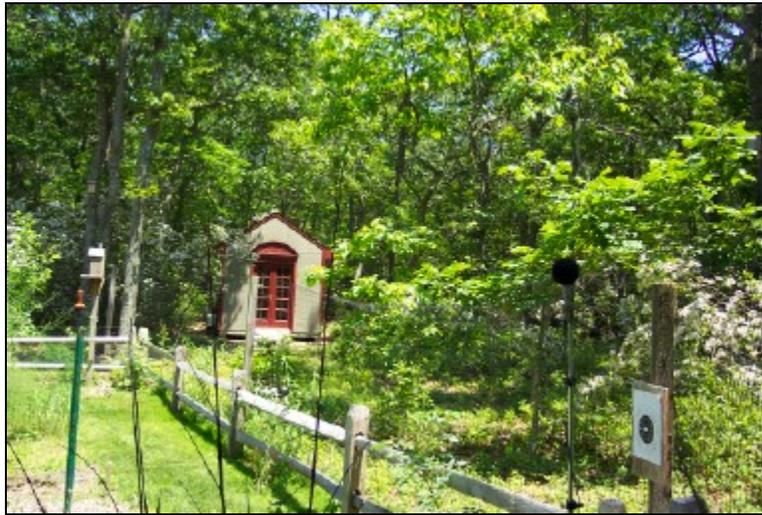
Figure 3. Microphone Location for Site 3

Site 3 was located in the backyard of a single-family home located at 244 Widow Gravitts in Bridgehampton. This site was northwest of the airport, approximately 7700 feet from the end of Runway 10/28 and 3200 feet north of the extended runway centerline. Figure 3 shows the location of the microphone in the backyard of this residence.

Site 3 also was selected to document helicopter traffic patterns and operations. The site is located roughly 500 feet south of a power line that is used as a reference for helicopter pilots on approach to Runway 16.

In general, helicopter operations generated the highest noise levels at Site 3. The measured SEL for noise events generated by observed helicopter operations ranged from 65 to 90 dBA, while the measured L_{max} for observed helicopter noise events ranged from 57 to 82 dBA.

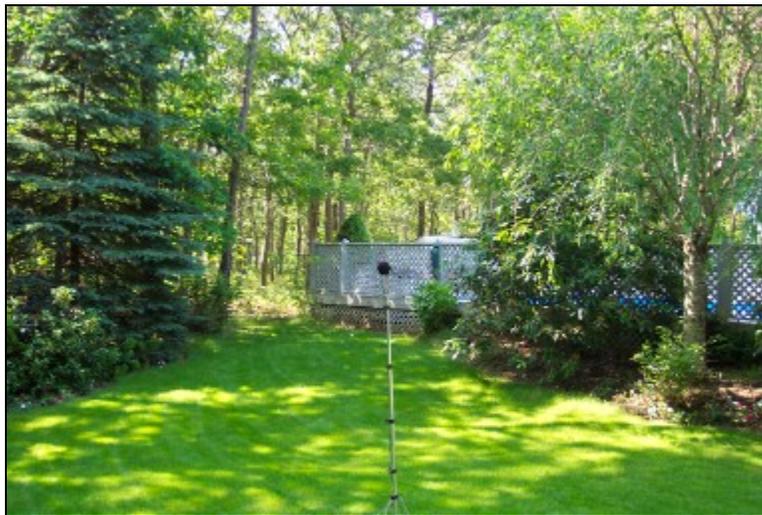
Figure 4. Microphone Location for Site 4

Site 4 was located in the backyard of a single-family home located at 75 West Gate in Wainscott. This site was south of the airport, approximately 1500 feet from the end of Runway 04/22 and 700 feet east of the extended runway centerline. Figure 4 shows the location of the microphone in the backyard of this residence.

Site 4 was selected to obtain noise levels and document aircraft operations to and from Runways 04/22 and 10/28. Attended noise measurements were conducted on June 27th from 09:45 to 12:15, on July 1st from 16:45 to 17:47, and on July 2nd from 10:50 to 12:55.

A helicopter operation generated the highest noise level at Site 4. The measured SEL for this observed noise event was 81 dBA, while the measured L_{max} for this observed noise event was 70 dBA.

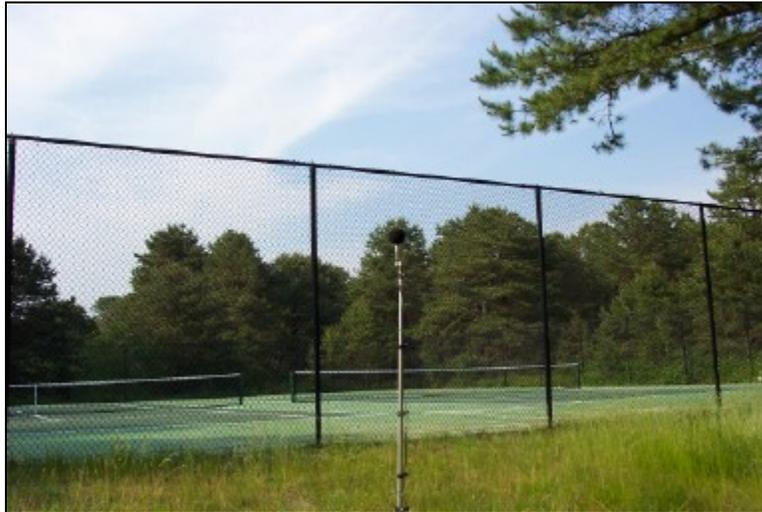
Figure 5. Microphone Location for Site 5

Site 5 was located near the tennis courts at Georgica Estates in East Hampton. This site was east of the airport, approximately 4700 feet from the end of Runway 10/28 and 500 feet south of the extended runway centerline. Figure 5 shows the location of the microphone in relation to the tennis courts.

Site 5 was selected to obtain noise levels and document aircraft operations to and from Runway 10/28. Attended noise measurements were conducted on June 26th from 15:06 to 17:34, on June 27th from 15:20 to 17:01, on July 1st from 15:40 to 19:08, and on July 8th from 11:30 to 12:37. The noise event threshold for this site was originally set at 50 dBA then, on June 26th at 17:34, the noise event threshold was changed to 55 dBA, and the monitor was moved to the location as shown in Figure 5.

In general, jet aircraft operations generated the highest noise levels at Site 5. The measured SEL for observed jet aircraft operations ranged from 68 to 96 dBA, while the measured L_{max} for observed jet aircraft ranged from 57 to 89 dBA.

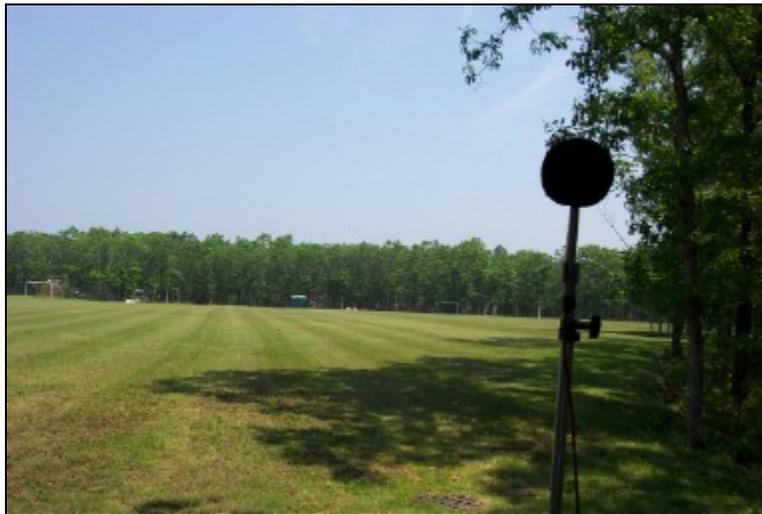
Figure 6. Microphone Location for Site 6

Site 6 was located near the athletic fields at the Ross School in Wainscott. This site was north of the airport, approximately 2000 feet from the end of Runway 04/22 and 600 feet east of the extended runway centerline. Figure 6 shows the location of the microphone in relation to the athletic fields.

Site 6 was selected to obtain noise levels and document aircraft operations to and from Runways 04/22 and 16/34. Attended noise measurements were conducted on June 26th from 14:50 to 15:49, on June 27th from 14:00 to 14:52, and on July 1st from 10:00 to 12:34.

In general, jet aircraft operations generated the highest noise levels at Site 6. The measured SEL for observed jet aircraft operations ranged from 71 to 81 dBA, while the measured L_{max} for observed jet aircraft ranged from 57 to 69 dBA.

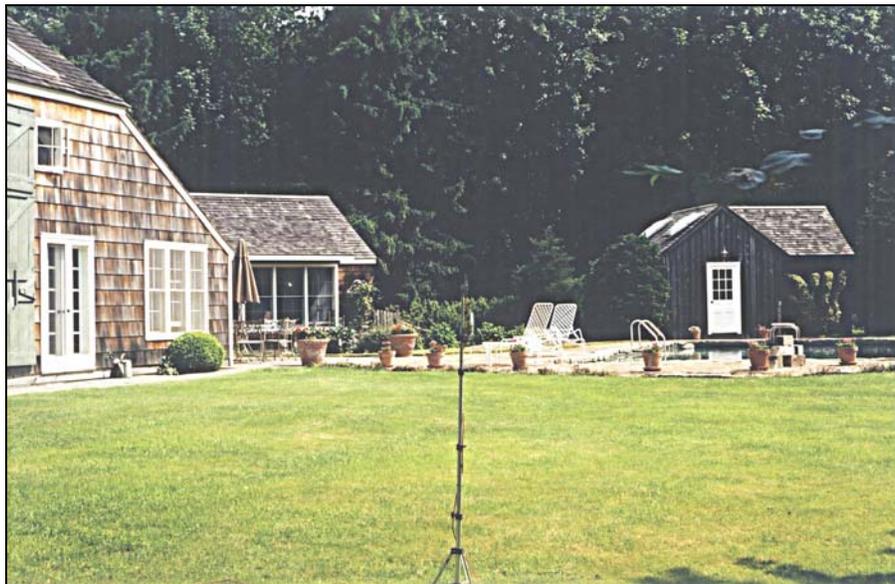
Figure 7. Microphone Location for Site 7

Site 7 was located in the backyard of a single-family home at 136 Main Street in East Hampton Village. This site was east of the airport, approximately 15000 feet from the end of Runway 10/28 and 500 feet south of the extended runway centerline. Figure 7 shows the location of the microphone in relation to the house.

Site 7 was selected to obtain noise levels and document aircraft operations for Runway 10/28. Attended noise measurements were conducted on July 2nd from 09:59 to 12:00, and on July 8th from 09:50 to 10:52.

The measured Total DNL ranged from 53 to 60 dBA over the 7-day period. The DNL due to measured noise events (both aircraft and non-aircraft) ranged from 41 to 59 dBA. The tables in Appendix B provide summaries of the measured DNL for all of the sites.
